Chapter 11 Steering System

Removing and Replacing the Rudder Shaft Seal

Donald Gordon, AT34-28 "Annie", has provided this write-up on how to remove and replace the rudder lip seal.

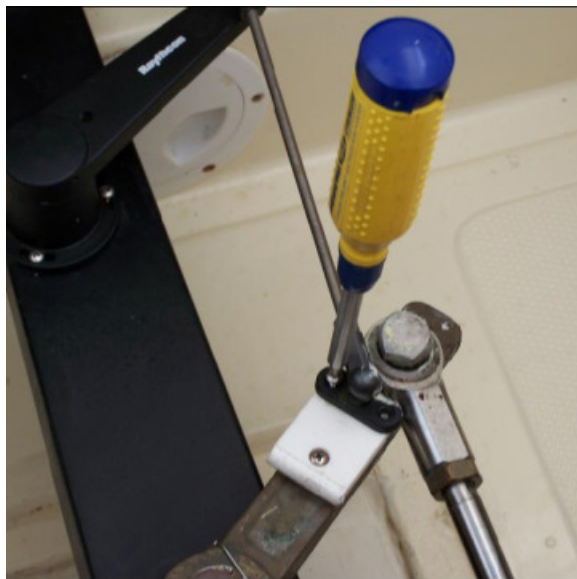
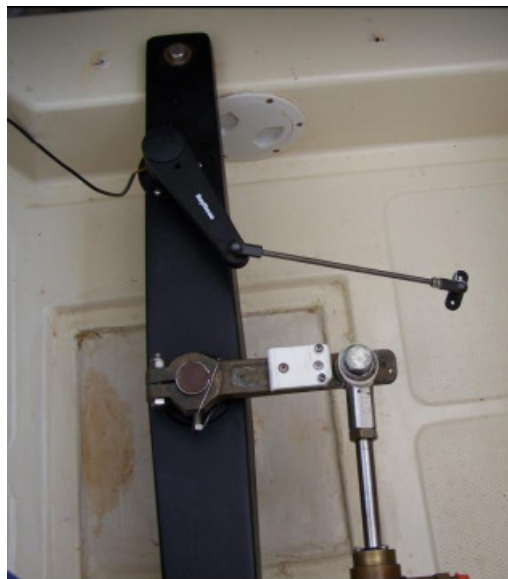
1. Remove Rudder cover – 4 Phillips head screws
2. Turn wheel hard over to starboard exposing both Raymarine attachment screws.
3. Remove Raymarine AP rudder indicator by loosening 2 screws on top of rudder tiller.

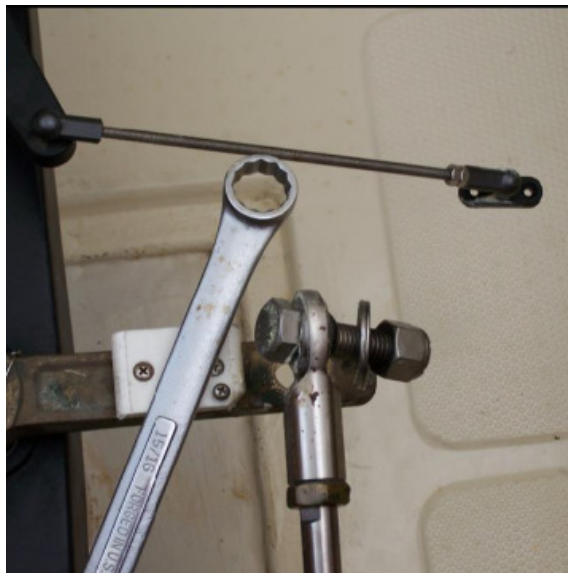
4. Remove RAM from tiller arm. 15/16 wrench. Remove nylock nut from bottom. Lift out vertically.

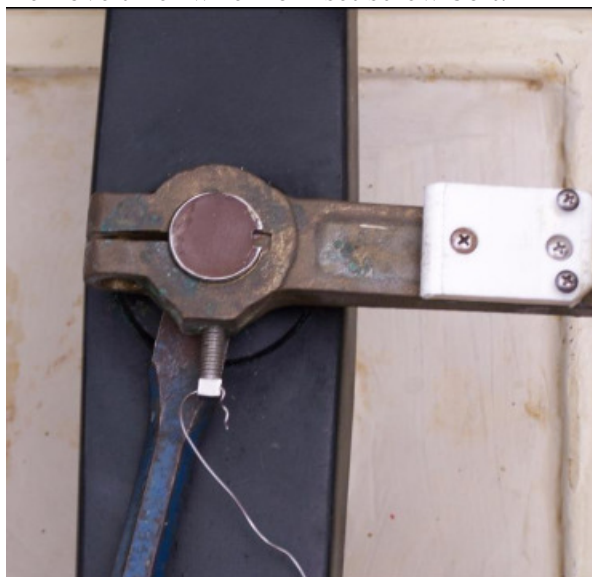
5. Remove tiller wire from set screw bolt.

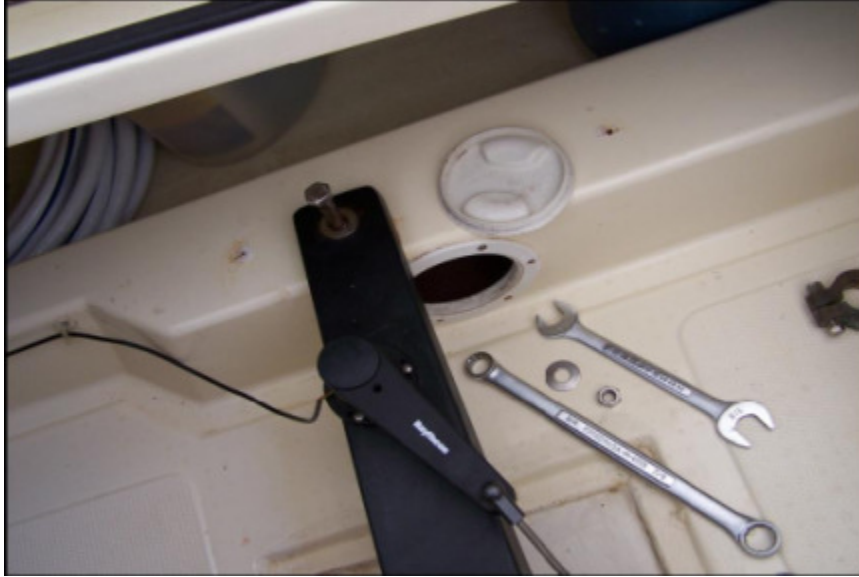
6. Loosen tiller set screw bolt on rudder post – 8 mm wrench.
7. Remove tiller arm nylock bolt – 9/16 wrench.
8. Gently pry up tiller with crowbar.
9. Remove tiller arm.
10. Open hand holds to access $\frac{3}{4}$ nuts holding black rudder base onto stringer at each end. Remove bolts.

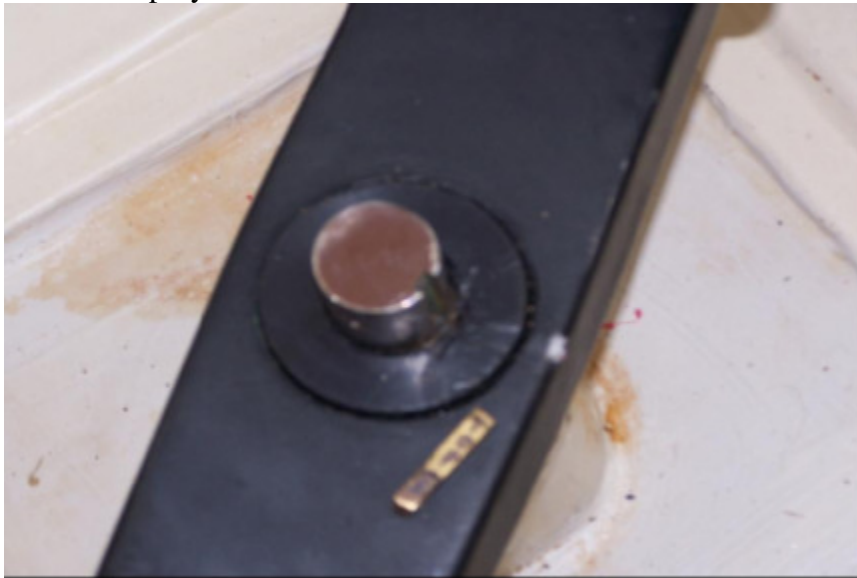
11. Remove shaft key – this was the hardest part. Screwdriver, crow bar, pliers, hammer & prayer.

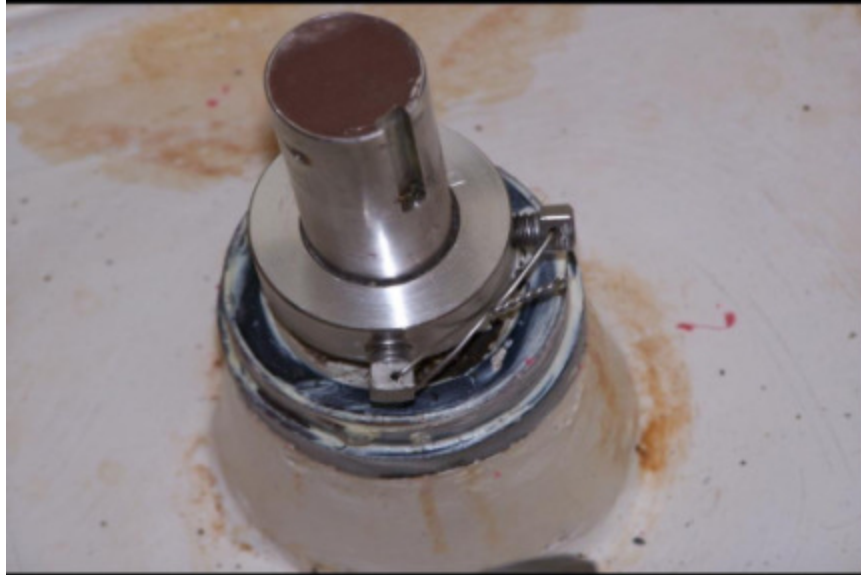
12. Remove the seizing wire from the bolts. Loosen set screw bolts – 3/8 wrench. Slide collar off.

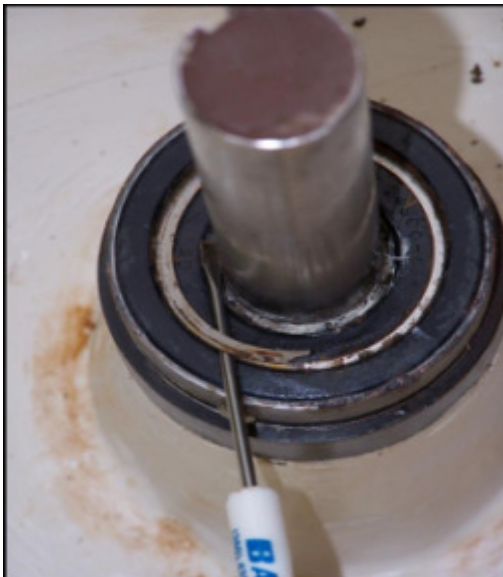
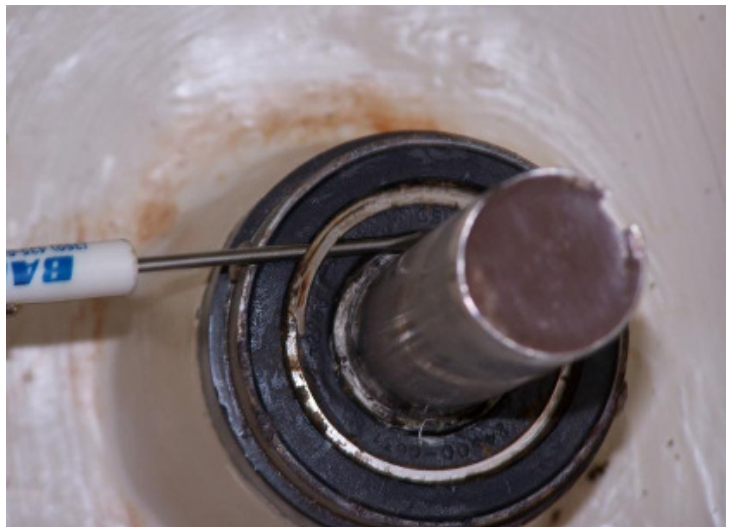
13. Find the spiral retaining ring and its 45 degree angle end. Using a small screwdriver, pry the end of the spiral ring off toward the shaft. Remove ring (it goes around twice) and set aside for re-installation later.

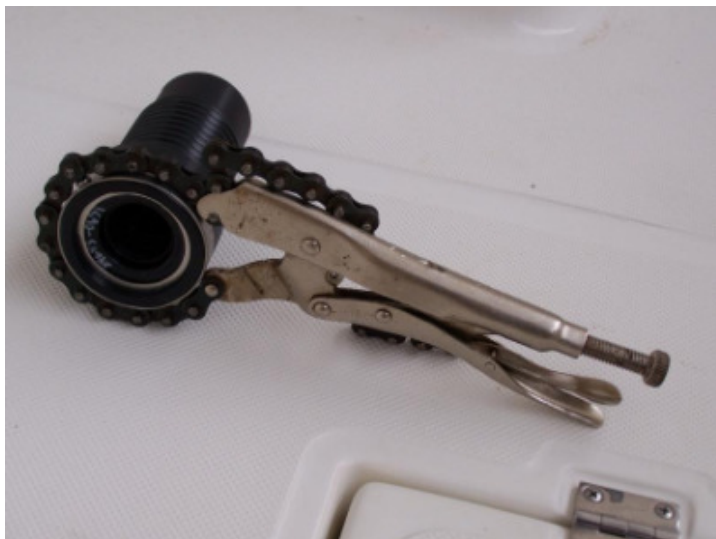
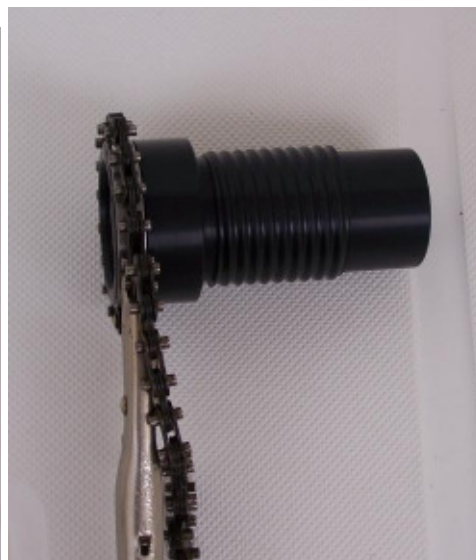
16. If you have purchased a new bearing with two lip seals (as mentioned above at the start of this section), you will need to remove the old bearing. To remove the bearing, use a chain wrench around the metal ring (with two screws in it).

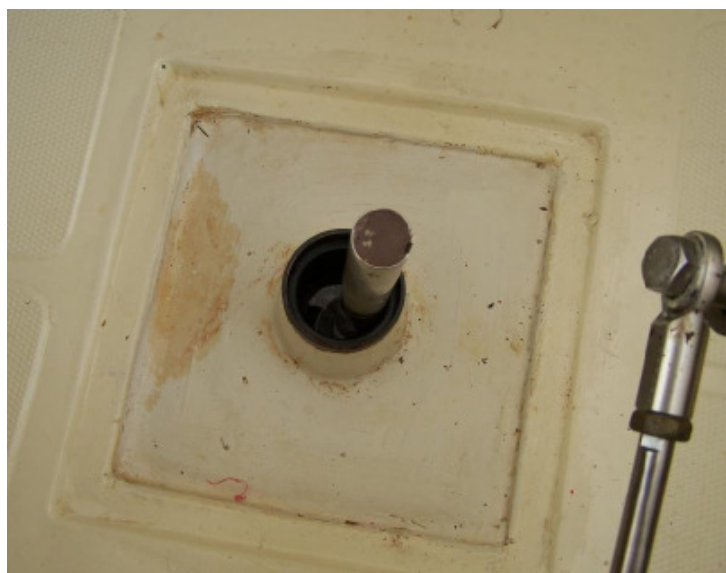
17. Clean shaft to remove any grease – I used brake cleaner.

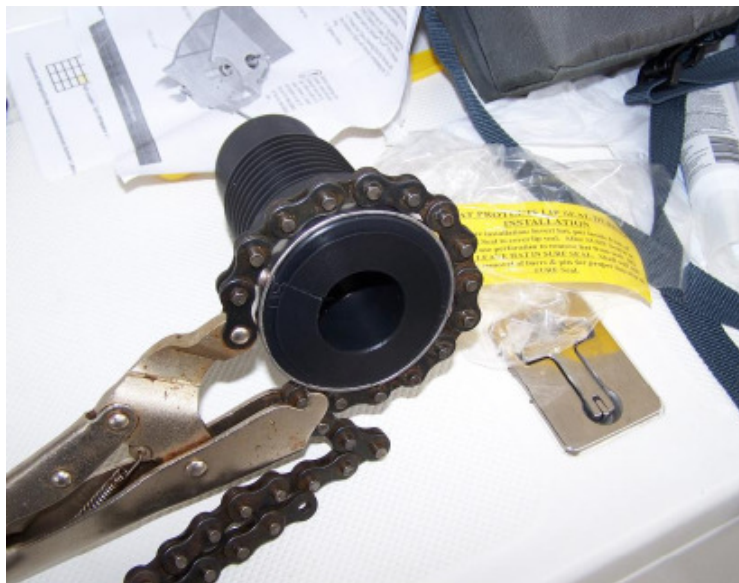
18. Position chain wrench on new bearing.

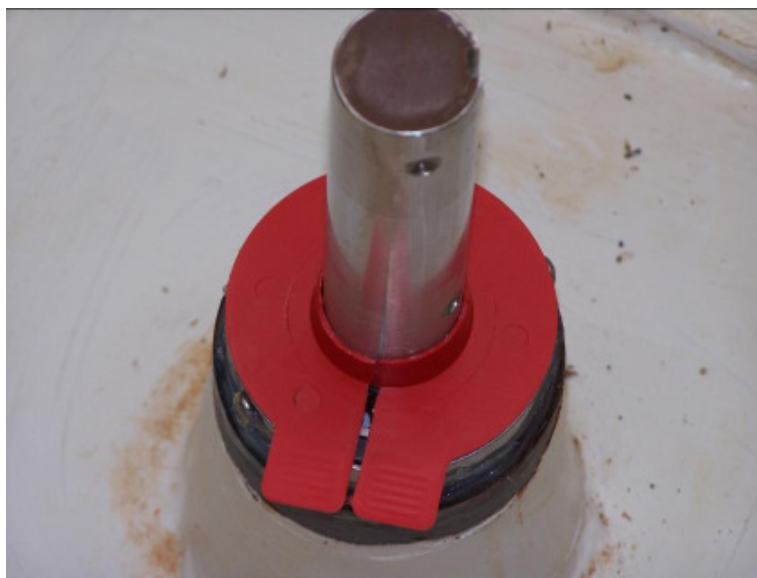
19. Install hat inside of bearing top to cover two lip seals.
20. Apply Life Caulk or Silicone Caulk around bearing shoulder inside o-ring. Apply another bead half way down spiral around 2 times.
21. Slide bearing onto shaft with hat installed & use chain wrench around SS ring to screw in and tighten down.
22. Remove hat from seals. Invert. Cut off 1/2" of hat bottom to clear collar. Place on shaft above seal to protect it.

The upper end of the rudder shaft is fitted into a bearing with the control arm attached. Unfortunately, the bearing and collar make a nice 'ledge' for seawater to sit and corrode. Tides marine recommends inverting the red "hat" to prevent intrusion of any foreign substance from the outside getting into the lip seal area. This is shown in the photo for step 22 in the section below.
