Chapter 12 Bow Thruster

The bow thruster is a Sidepower model SP75T (SP80T on later boats), mounted upright under the forward berth. To get to it, lift up the mattress, and remove the 2 rectangular interlocking access covers. The bow thruster is under yet another cover, in that big soundproofed box in the middle of that area.

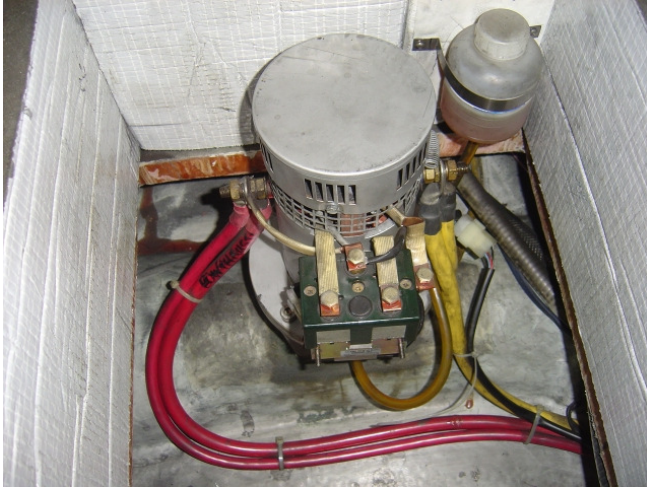
Around 2005 there was a minor change to this thruster to add 'IPC (Intelligent Power Control) circuitry. This circuitry compares the low-power joystick signal with the high-power motor draw, to prevent running of the thruster if the solenoid contacts stick 'on'. (Underneath the black solenoid cover, the IPC thruster has 3 wires on the starboard side, and the pre-IPC one has only 2). It's hard to see, but the thruster in the photo is a pre-IPC model.

In the picture above, a black plastic cover over the solenoid pack has been removed prior to troubleshooting.

There are 2 little metal pins on the outside of this cover. They are spare shear pins for the thruster propellers.

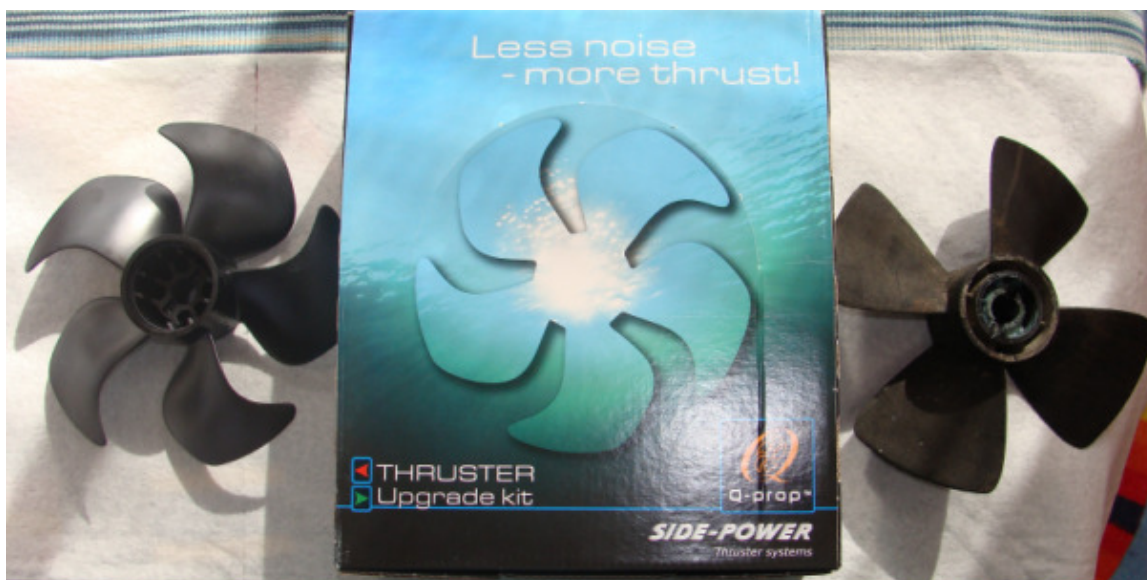
Starting in 2008, Sidepower made a change to the propellers on their thrusters, changing from a 4-bladed prop to a new 5-bladed “Q-prop”. The claim is that they provide about 7 percent more thrust and are 20 to 40 percent quieter than the old 4-bladed prop in a typical installation.

The picture below shows the new prop (to the left of the box) and the old prop (to the right of the box).

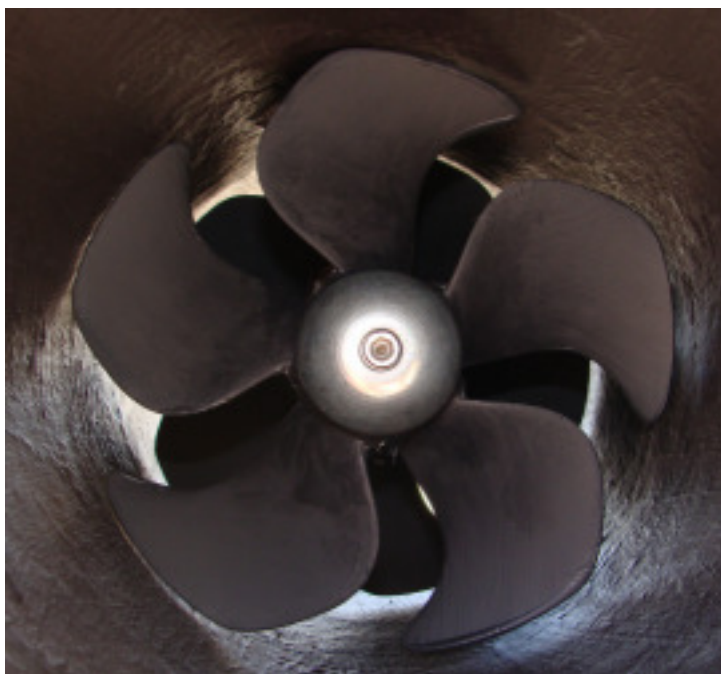
As promised, they were easily installed with the supplied adaptor boss. The kit includes the two props, adaptors, 2 new zincs, prop nuts and shear pins. The picture below shows the new props installed.

We had the yard 'bead-blast' the props before applying a couple of coats of bottom paint. The bead-blasting prepares the surface so that the bottom paint would adhere better.

We have to report that we honestly did not notice any marked reduction in the sound. It may be a little quieter, but we did not see the 20-40 percent reduction in noise as promised in a 'typical' installation.

We did, however, notice a marked improvement in the amount of power. I guess one out of two ain't bad – and to be honest, I'll take the increase in power over the reduction in noise any day...
