Chapter 18 Underwater Maintenance

Zincs

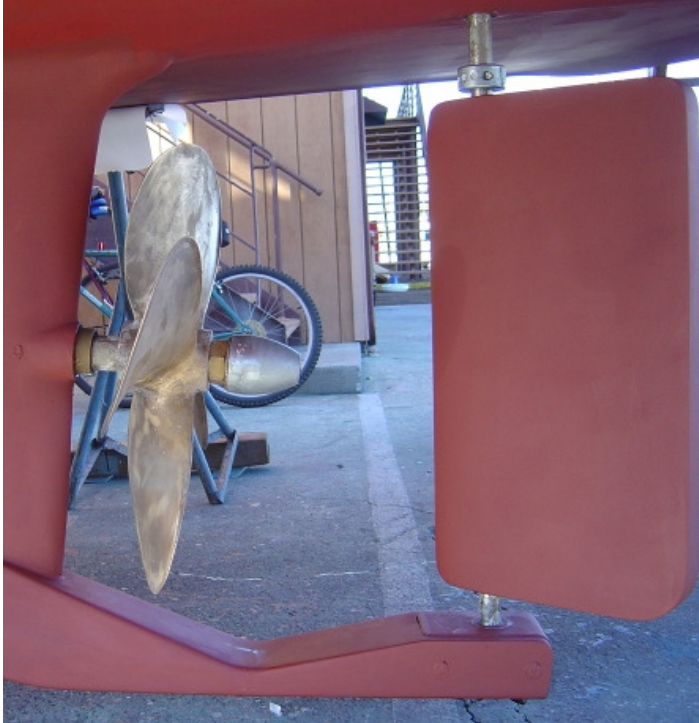
Depending on the amount of clearance available on the AT34, the propeller and shaft have either a 2in Limited Clearance shaft zinc (CAMP part#CMC09 / West Marine part#485284), or a Camp 'H' prop zinc carried on special propshaft nut (CAMP #CMPNHCZ06/West # 132557 (Zinc+nut) or CMPNZH/132706 (Zinc only). The later is what we have on our boat as shown in the photo above.

The rudder shaft should have a 1 1/4in donut shaft zinc (CAMP CMC05 / West #485086). Early Tugs did not have this installed at the factory. If you do not have one, you should. It can be installed above the rudder (as in the photo above) or below.

If you have the Camp 'H' as we do, the factory replace the original slotted screw with a 5/16in X 3/4 hex-head screw, so that divers can apply more leverage when installing a new zinc.

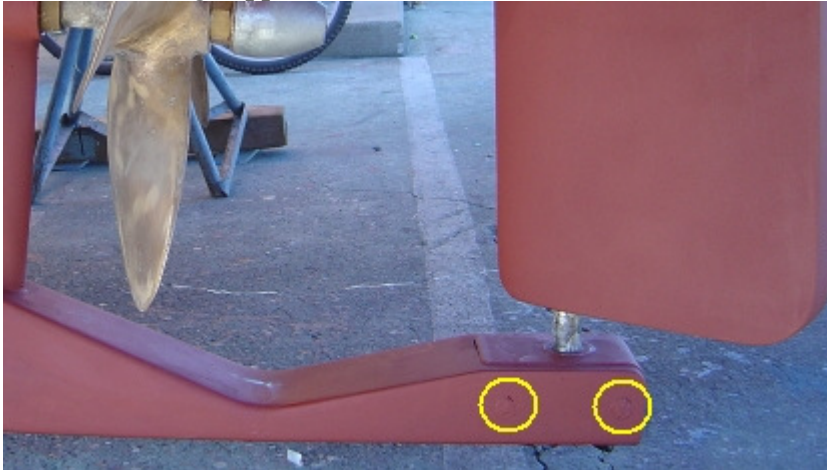
Rudder bearing support bolts

These bolts provide hold the lower rudder bearing, and are usually covered in sealant or bottom paint. The location is shown by the yellow circles in the photo below.

The 2 bolts are 3/8in diameter and 5in long AT34) or 5 3/4in long (AT41), low-carbon stainless-steel with Nylock nuts, and Tomco now recommend they *should be removed and replaced every second year*. The Wrench size is 9/16 in (you need 2).

Crevice corrosion has been found on the rudder bearing support bolts of some of the first AT34s. I've found some corrosion and metal-loss around the threads and head area after 2 years underwater.

Alternatively bronze bolts can be substituted, which should be *removed and replaced every 10 years*. McMaster-Carr sell these (<http://www.mcmaster.com>)
- Part# 93516A640. Silicon Bronze Head Cap Screw 3/8in – 16 thread 5in long.

There is a stainless flat washer underneath the bolt and nut on each side that needs to be dug out. I found the best way was to push the old SS bolt back flush with the washer, then jam a wedge between the bolt and the washer, and tap the bolt. Tricky, but it worked.
